Prompt Report on Landslides Triggered by the 2018 Hokkaido Eastern Iburi Earthquake on September 6, 2018

Prompt Disaster Survey Team on landslide disasters triggered by the 2018 Hokkaido Eastern Iburi Earthquake

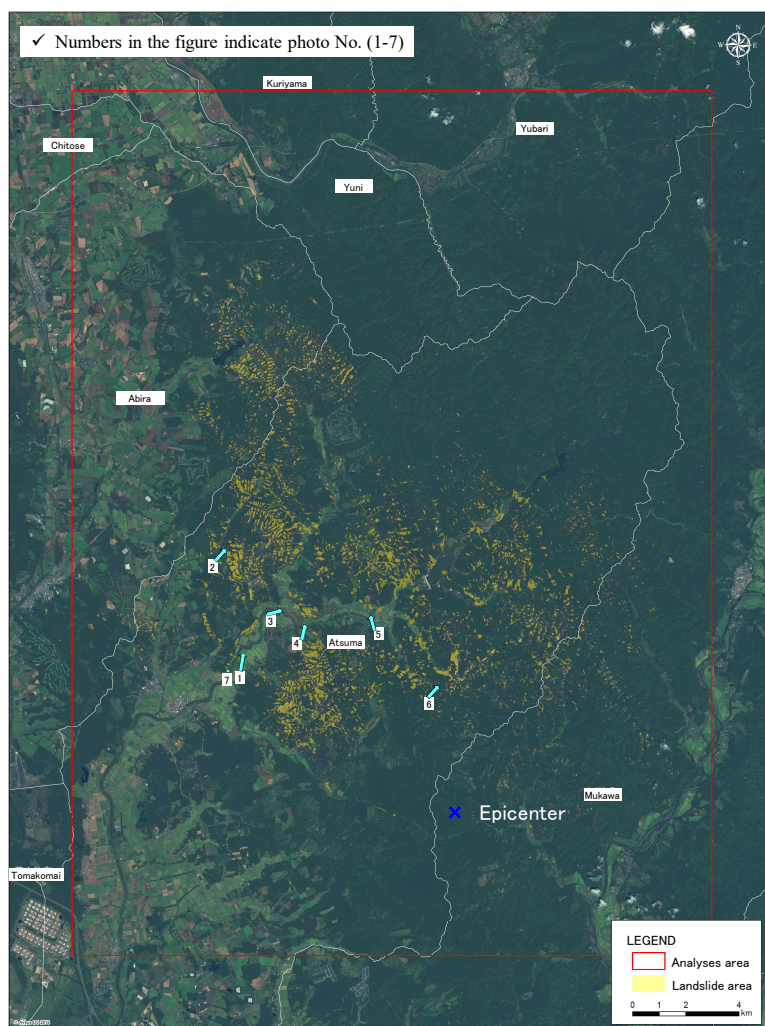
Fig. 3 Distribution of landslide areas based on a SPOT satellite image (taken on September 11, 2018) analyses (provided by Pasco Corporation)

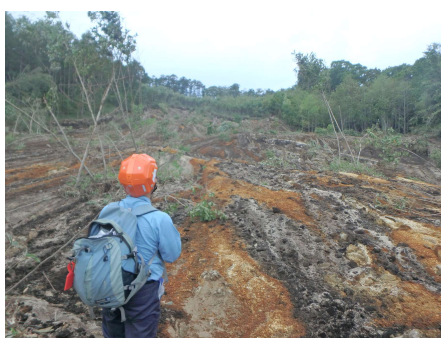
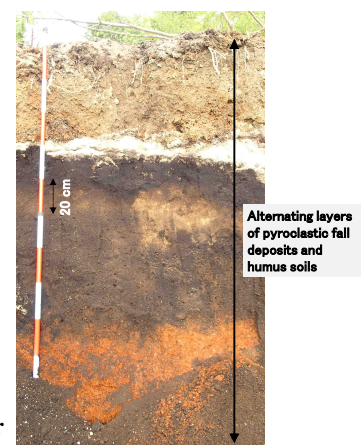
Photo 7
Landslide at Sakuraoka area and outcrop observed at the side of the landslide scar
